**Urban Mass
Transportation
Administration**

Evaluation and Testing of Rail Transit Undercar Fire Detection and Suppression Systems

Ketron, Inc.
58 Charles Street
Cambridge, MA 02141

August 1989
Final Report

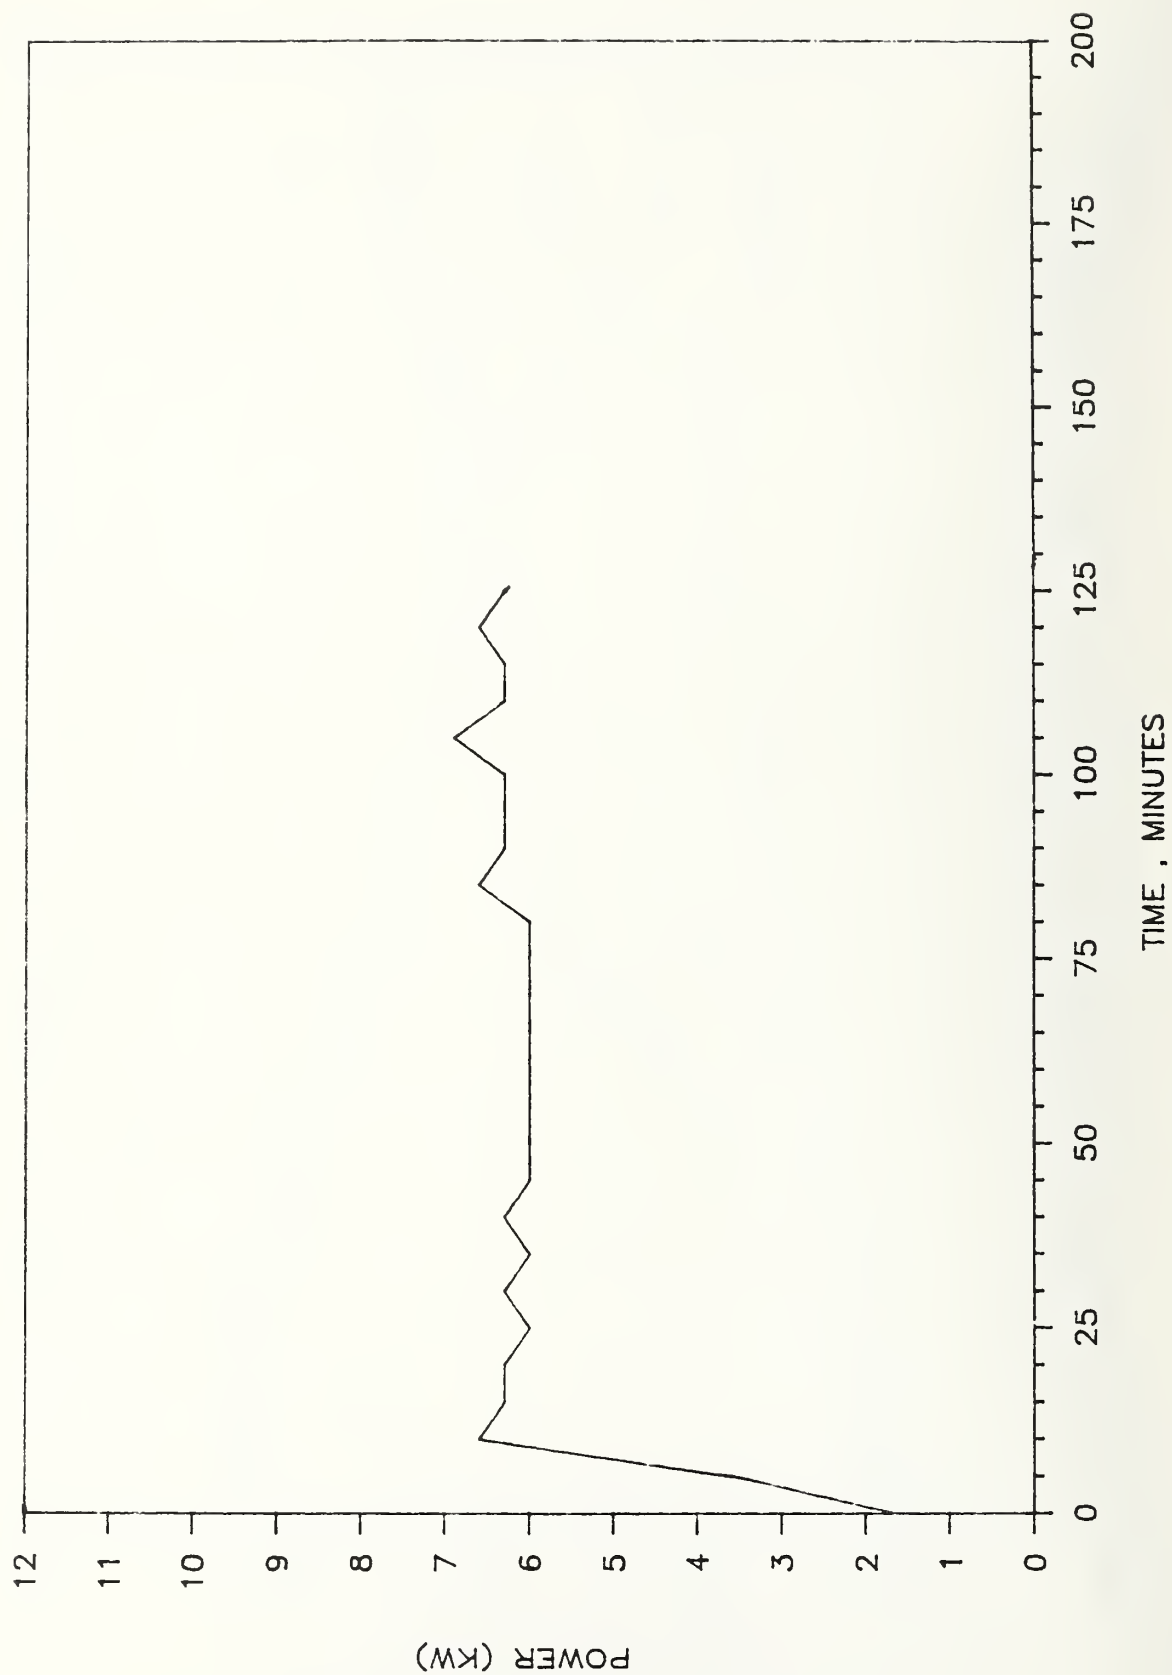
FIGURE A-13. TEST NUMBER 5, POWER LEVEL

FIGURE A-14. TEST NUMBER 5, THERMOCOUPLES 3, 4, 5, 6

FIGURE A-15. TEST NUMBER 5, THERMOCOUPLES 7, 9, 10

FIGURE A-16. TEST NUMBER 5, THERMOCOUPLES 0, 1, 2

FIGURE A-17. TEST NUMBER 5, THERMOCOUPLES 12, 13, 15, 16
